Galling Prevention and Run-In Torque Reduction

An aircraft structures manufacturing company was encountering galling when installing titanium bolts (type NAS1581) to threaded stainless steel nut-plates (type MS21060L6). The fastener system is used to attach a large exterior communications structure to the airframe.

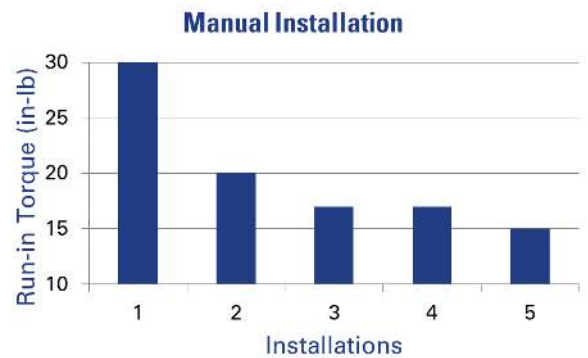
Manual Installation:

As shown, the run-in torque was low and decreased with every installation/removal cycle. No evidence of galling was noted and the coating was found to be in good condition throughout the test.

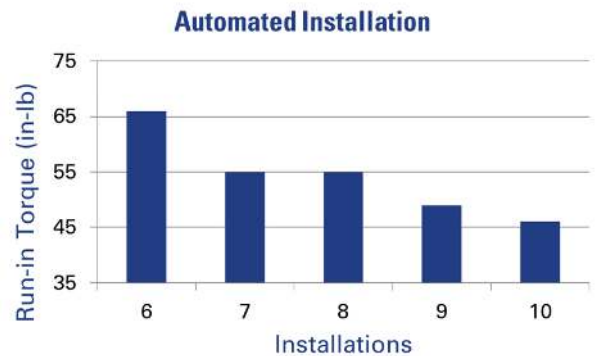
Automated Installation:

The run-in torque measured after the 5th cycle was 32 in-pounds and no evidence of galling or coating loss was noted. The data from the subsequent five cycles (#s 6-10) is shown. Interestingly, the 6th cycle run-in torque was higher but then consistently decreased with each cycle. No evidence of galling was noted throughout; minimal coating degradation was observed.
